**Flood Control Project Maintenance
Levee Inspections**
LMA District Cover Sheet
Spring 2018 Levee Inspection Results

Butte County Department of Public Works

Unit Cover Sheet

Spring 2018 Levee Inspection Results

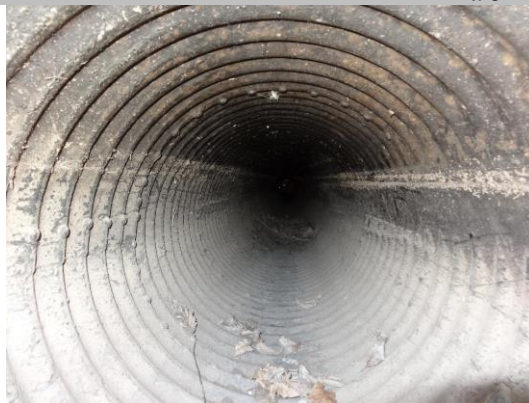
Photo 3 of 3 : UCIP_SP_2018_29705_54922.jpg

LS view: inside view of CMP on levee slope. Looks clean and clear.

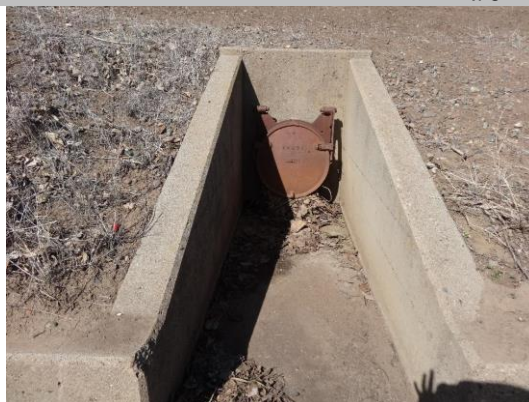
Photo 1 of 3 : UCIP_SP_2018_32044_58543.jpg

LM Start	1.00	Rating **	M	Issue No.	60	
LM End	1.00	Issue Type +	Ma	Location *		
Category	Supplemental			GPS Latitude/Longitude		
				Start		End
Item	DWR UCIP LMA Responsibility			39.739268 °	39.739268 °	
				-121.931891 °	-121.931891 °	
DWR ID						
Comment Code						
Inspector Comment						
FS_ID:32044 DS_ID:19211 EP_NO: N/A Repair Type: Non-Urgent Crossing Status: Found UCIP Comments: Vegetation debris on waterside. Needs clearing and cleaning. FIELD_STRUCT_DESC: 24-inch corrugated metal gravity drainage pipe through the levee, 12 feet below the crown. Flap gate on the waterside (WS) end. Concrete U-shaped headwall on each end. Grouted riprap apron on the landside (LS) end. Grouted riprap spillway on the WS end. [Additional Reference(s): DWR Levee Log, 1992. USACE Sacramento O&M Manual 504, May 1965, (HLM 1.03)]. FS Date: 2/20/2014

WS view: U typed concrete headwall, pipe, and flapgate on levee slope.

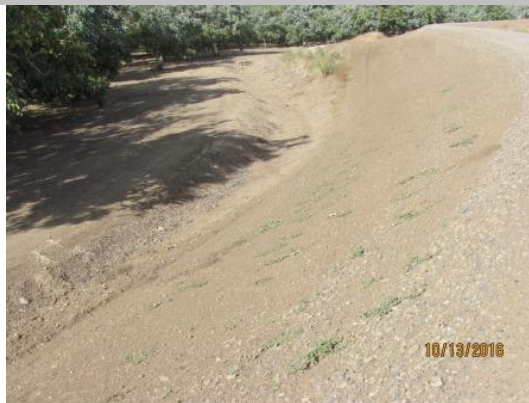
Photo 1 of 1 : SP_2018_NA0003_64_46_20180305_00025.jpg

LM Start	1.19	Rating **	M	Issue No.	46
LM End	1.25	Issue Type +	En	Location *	LS
Category	Earthen Levee			GPS Latitude/Longitude	
				Start	End
Item	Encroachments			39.740082 °	39.740697 °
				-121.928383 °	-121.927844 °
DWR ID	DWR_NA0003_01_f_2016_46				
Comment Code					
DT : Ditch					
Inspector Comment

View of a ditch along the toe.

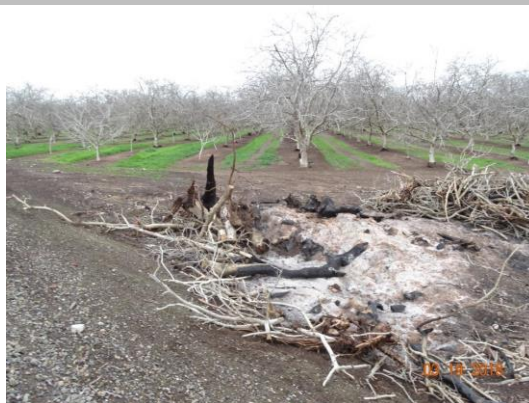
Photo 1 of 1 : SP_2018_NA0003_64_15_20180402_00070.jpg

View of the prunings along the landside toe.

LM Start	1.69	Rating **	M	Issue No.	15
LM End	1.69	Issue Type +	En	Location *	LS
Category	Earthen Levee			GPS Latitude/Longitude	
				Start	End
Item	Encroachments			39.745718 °	39.745718 °
				-121.923124 °	-121.923124 °
DWR ID	DWR_NA0003_01_s_2014_15				
Comment Code					
PR : Prunings					
Inspector Comment					
Remove the prunings from the landside toe

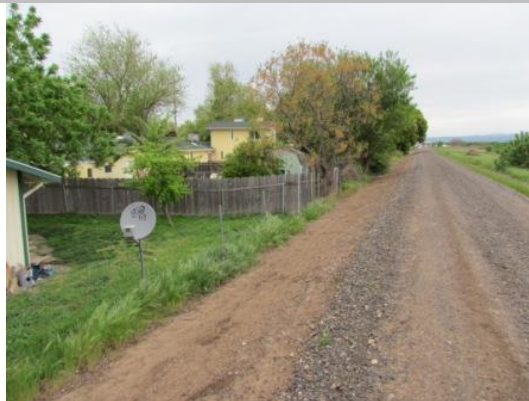
Photo 1 of 1 : SP_2018_NA0003_64_3_20180305_00002.jpg

LM Start	2.00	Rating **	M	Issue No.	3
LM End	2.04	Issue Type +	En	Location *	LS
Category	Earthen Levee			GPS Latitude/Longitude	
				Start	End
Item	Encroachments			39.748330 °	39.748867 °
				-121.918685 °	-121.918533 °
DWR ID	DWR_NA0003_01_s_2012_3				
Comment Code					
FE : Fence					
Inspector Comment

View of the fences along the landside toe.

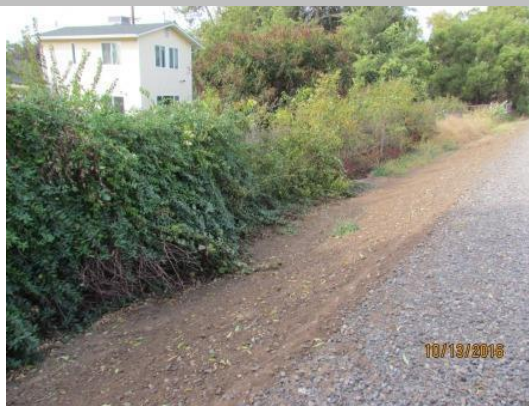
Photo 1 of 1 : SP_2018_NA0003_64_48_20180305_00026.jpg

LM Start	2.03	Rating **	M	Issue No.	48
LM End	2.11	Issue Type +	En	Location *	LS
Category	Earthen Levee			GPS Latitude/Longitude	
				Start	End
Item	Vegetation			39.748784 °	39.749872 °
				-121.918597 °	-121.918296 °
DWR ID	DWR_NA0003_01_f_2016_48				
Comment Code					
V6 : Landscaping					
Inspector Comment

View of landscaping vegetation blocking visibility.

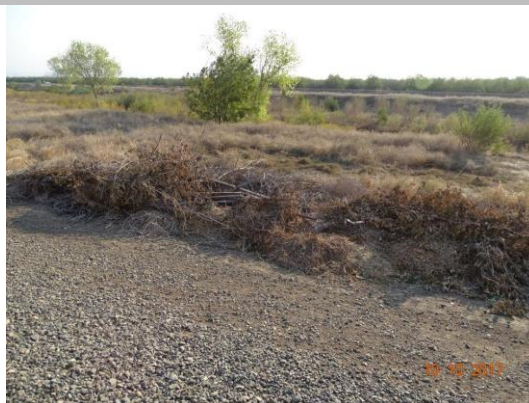
Photo 1 of 1 : SP_2018_NA0003_64_57_20180305_00035.jpg

View of the prunings along the waterside toe.

LM Start	2.12	Rating **	M	Issue No.	57
LM End	2.12	Issue Type +	En	Location *	WS
Category	Earthen Levee			GPS Latitude/Longitude	
				Start	End
Item	Encroachments			39.750037 °	39.750037 °
				-121.918237 °	-121.918237 °
DWR ID	DWR_NA0003_01_f_2017_57				
Comment Code					
PR : Prunings					
Inspector Comment					
Remove the prunings from the waterside toe.

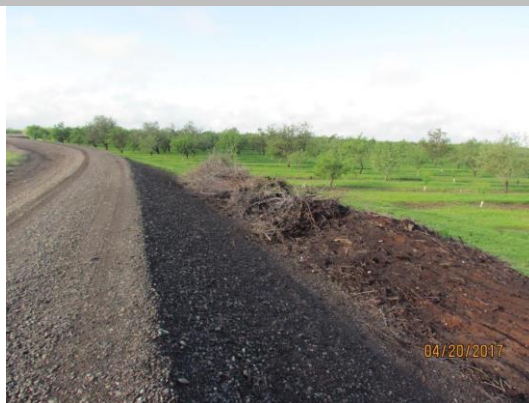
Photo 1 of 2 : SP_2018_NA0003_64_49_20180305_00027.jpg

View of the prunings along the landside toe.

LM Start	2.59	Rating **	M	Issue No.	49
LM End	2.59	Issue Type +	En	Location *	LS
Category	Earthen Levee			GPS Latitude/Longitude	
				Start	End
Item	Encroachments			39.755930 °	39.755930 °
				-121.914829 °	-121.914829 °
DWR ID	DWR_NA0003_01_f_2016_49				
Comment Code					
PR : Prunings					
Inspector Comment					
Remove prunings from the landside toe.

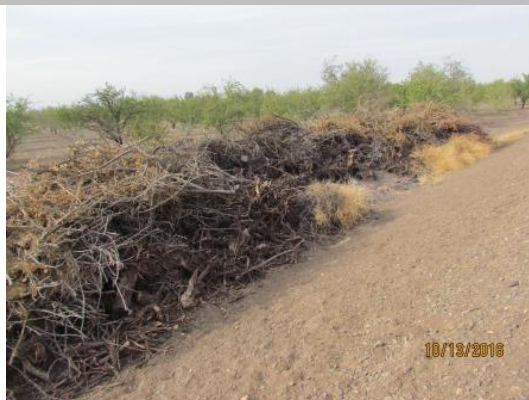
Photo 2 of 2 : SP_2018_NA0003_64_49_20180305_00028.jpg

View of the prunings along the landside toe.

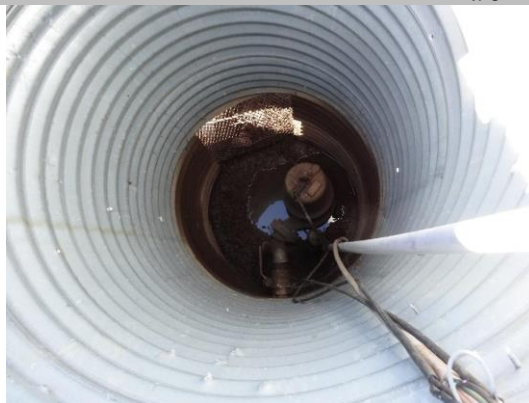
Photo 3 of 3 : UCIP_SP_2018_30291_55698.jpg

LS view: inside view of CMP riser. Pipe, gate valve, air vent, and submersible pump in the riser.

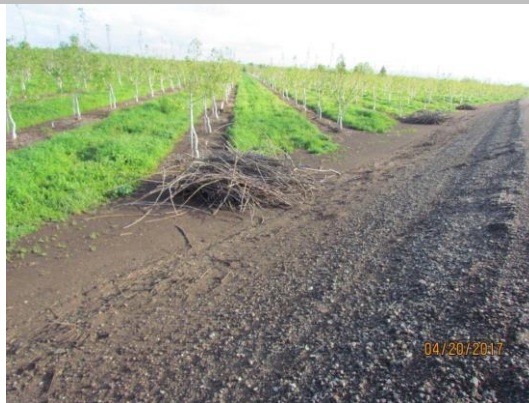
Photo 1 of 1 : SP_2018_NA0003_64_56_20180305_00034.jpg

LM Start	2.74	Rating **	M	Issue No.	56
LM End	2.74	Issue Type +	En	Location *	LS
Category	Earthen Levee			GPS Latitude/Longitude	
				Start	End
Item	Encroachments			39.757763 °	39.757763 °
				-121.913320 °	-121.913320 °
DWR ID	DWR_NA0003_01_s_2017_56				
Comment Code					
PR : Prunings					
Inspector Comment

View of the prunings along the landside toe.

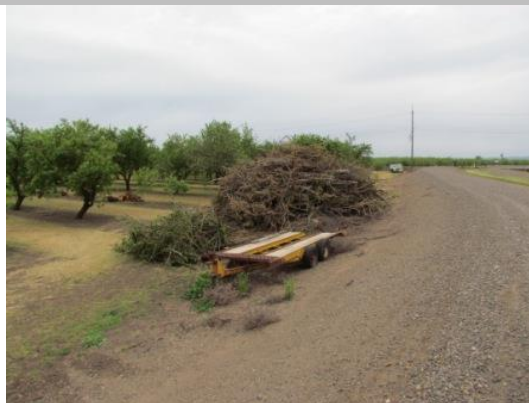
Photo 1 of 1 : SP_2018_NA0003_64_1_20180305_00001.jpg

View of the pruning pile along the landside toe.

LM Start	2.93	Rating **	M	Issue No.	1
LM End	2.93	Issue Type +	En	Location *	LS
Category	Earthen Levee			GPS Latitude/Longitude	
				Start	End
Item	Encroachments			39.759755 °	39.759755 °
				-121.911160 °	-121.911160 °
DWR ID	DWR_NA0003_01_s_2012_1				
Comment Code					
PR : Prunings					
Inspector Comment					
Remove the prunings from the landside slope.

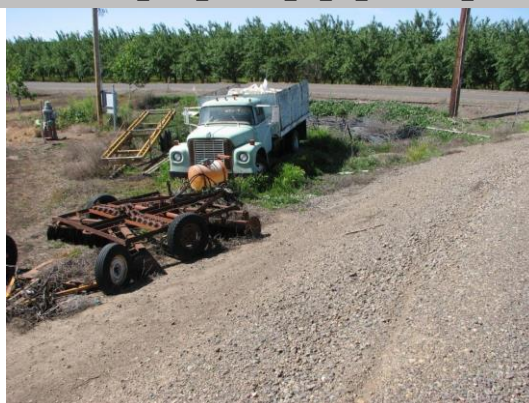
Photo 1 of 1 : SP_2018_NA0003_64_39_20180305_00020.jpg

LM Start	2.98	Rating **	M	Issue No.	39
LM End	2.98	Issue Type +	En	Location *	LS
Category	Earthen Levee			GPS Latitude/Longitude	
				Start	End
Item	Encroachments			39.760539 °	39.760539 °
				-121.911376 °	-121.911376 °
DWR ID	DWR_NA0003_01_s_2016_39				
Comment Code					
AV : Abandoned vehicles					
Inspector Comment					
Truck and farm equipment blocking landside toe.

View of equipment and vehicles along the landside toe.

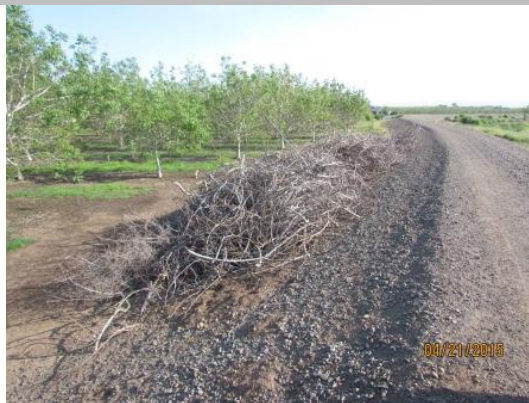
Photo 1 of 2 : SP_2018_NA0003_64_31_20180305_00013.jpg

View of the prunings along the landside slope.

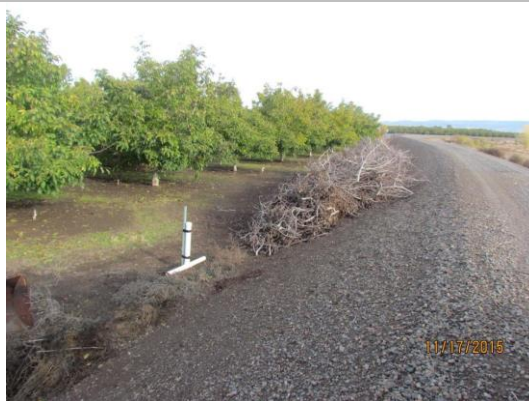
Photo 2 of 2 : SP_2018_NA0003_64_31_20180305_00014.jpg

View of the prunings and bait station along the landside slope.

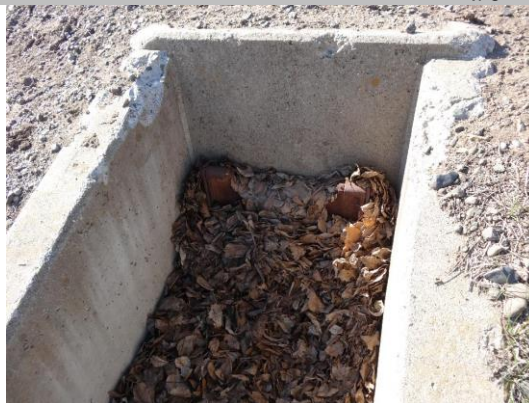
Photo 1 of 2 : UCIP_SP_2018_30295_55706.jpg

WS view: U type concrete headwall, flapgate on levee slope. Vegetation debris blocking the outlet.

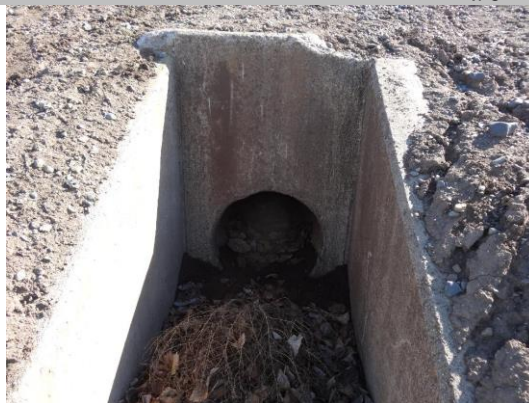
Photo 2 of 3 : UCIP_SP_2018_30310_55740.jpg

Comment Code						
Inspector Comment						
FS_ID:30310						
DS_ID:19218						
EP_NO: N/A						
Repair Type: Non-Urgent						
Crossing Status: Found						
UCIP Comments: Needs cleaning and clearing of debris.						
FIELD_STRUCT_DESC: 24-inch corrugated metal gravity drainage pipe						
through the levee, 10 feet below the crown. Flap gate on the waterside						
(WS) end. Concrete U-shaped headwall on each end. Grouted riprap						
apron on the landside (LS) end. Grouted riprap spillway on the WS end.						
[Additional Reference(s): DWR Levee Log, 1992. USACE Sacramento						
O&M Manual 504, May 1965, (HLM 3.48)].						
FS Date: 2/20/2014

LS view: U type concrete headwall and CMP on levee slope.

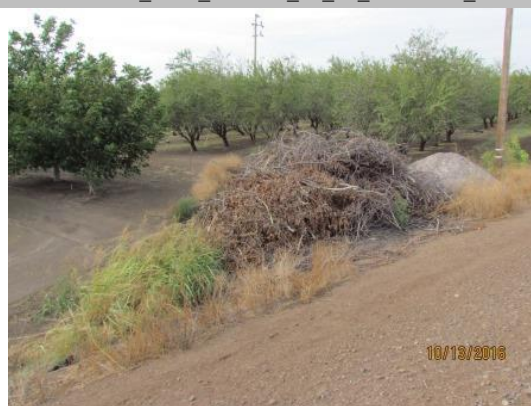
Photo 1 of 1 : SP_2018_NA0003_64_50_20180305_00029.jpg

LM Start	3.70	Rating **	M	Issue No.	50
LM End	3.70	Issue Type +	En	Location *	LS
Category	Earthen Levee			GPS Latitude/Longitude	
				Start	End
Item	Encroachments			39.767920 °	39.767920 °
				-121.902520 °	-121.902520 °
DWR ID	DWR_NA0003_01_f_2016_50				
Comment Code					
PR : Prunings					
Inspector Comment					
Remove prunings from the landside toe.

View of the prunings along the landside toe.

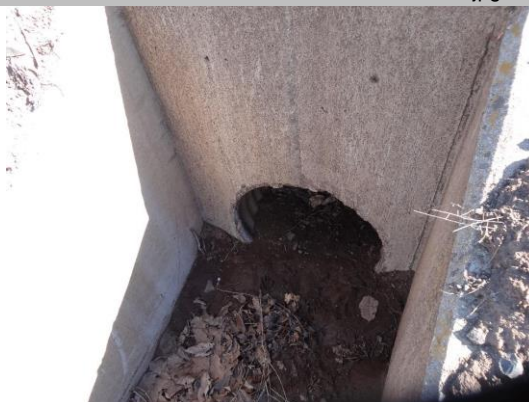
Photo 2 of 2 : UCIP_SP_2018_30311_55742.jpg

LS view: U type concrete headwall and CMP on levee slope.

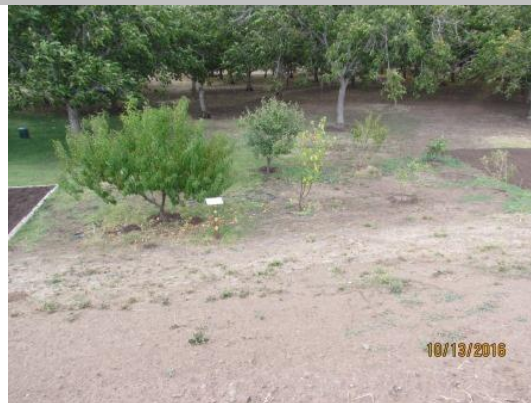
Photo 1 of 1 : SP_2018_NA0003_64_29_20180305_00011.jpg

LM Start	4.01	Rating **	M	Issue No.	29
LM End	4.01	Issue Type +	En	Location *	LS
Category	Earthen Levee			GPS Latitude/Longitude	
				Start	End
Item	Encroachments			39.771732 °	39.771732 °
				-121.899699 °	-121.899699 °
DWR ID	DWR_NA0003_01_f_2014_29				
Comment Code					
CR : Crops					
Inspector Comment					
Fruit trees at the toe of the levee.

View of the fruit trees within 10' of landside levee toe.

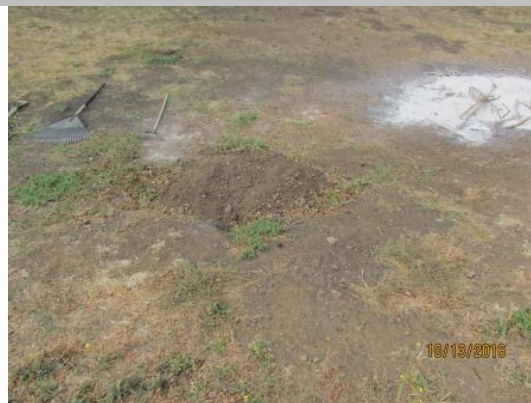
Photo 1 of 1 : SP_2018_NA0003_64_51_20180305_00030.jpg

LM Start	4.03	Rating **	M	Issue No.	51
LM End	4.03	Issue Type +	Ma	Location *	LS
Category	Earthen Levee			GPS Latitude/Longitude	
				Start	End
Item	Animal Control			39.771877 °	39.771877 °
				-121.899441 °	-121.899441 °
DWR ID	DWR_NA0003_01_f_2016_51				
Comment Code					
A1 : Exterminate rodents and backfill and compact or grout burrows.					
Inspector Comment

View of the rodent holes along the landside slope.

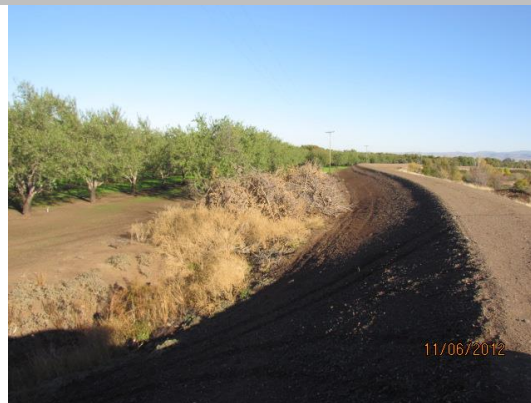
Photo 1 of 1 : SP_2018_NA0003_64_21_20180305_00004.jpg

LM Start	4.46	Rating **	M	Issue No.	21
LM End	4.46	Issue Type +	En	Location *	LS
Category	Earthen Levee			GPS Latitude/Longitude	
				Start	End
Item	Encroachments			39.775908 °	39.775908 °
				-121.893947 °	-121.893947 °
DWR ID	DWR_NA0003_01_s_2012_21				
Comment Code					
PR : Prunings					
Inspector Comment					
Remove the prunings from the landside slope.

View of the brush pile along landside toe.

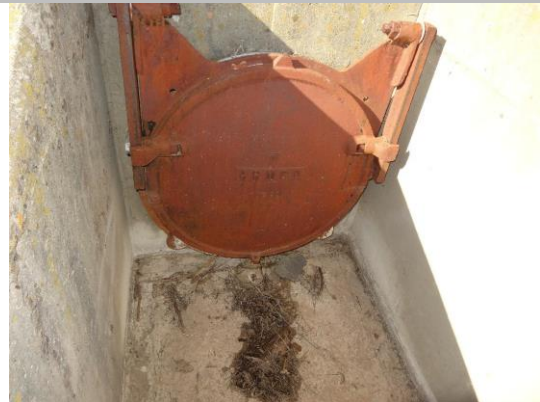
Photo 1 of 3 : UCIP_SP_2018_30327_55768.jpg

WS view: U type concrete headwall, pipe, and flapgate on levee slope.

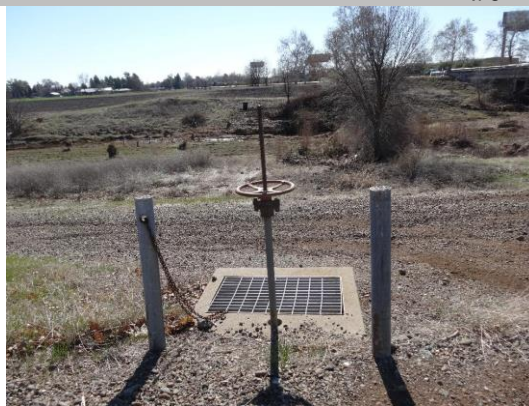
Photo 1 of 3 : UCIP_SP_2018_30368_55861.jpg

WS view: slide gate in concrete box on levee slope.

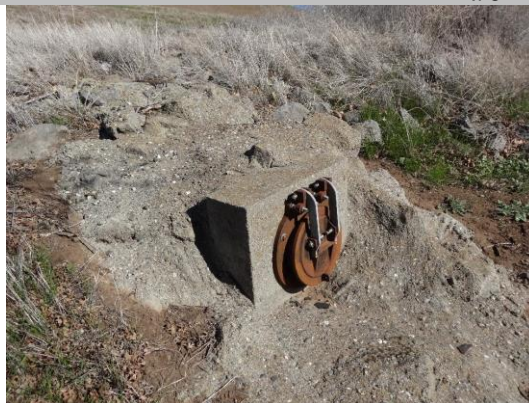
Photo 2 of 3 : UCIP_SP_2018_30368_55860.jpg

WS view: concrete headwall and flapgate on levee slope.

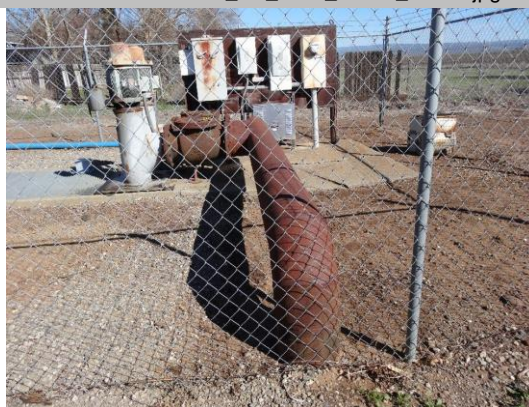
Photo 3 of 3 : UCIP_SP_2018_30368_55859.jpg

LS view: pipe, pumps, power boxes, concrete vault on landside.

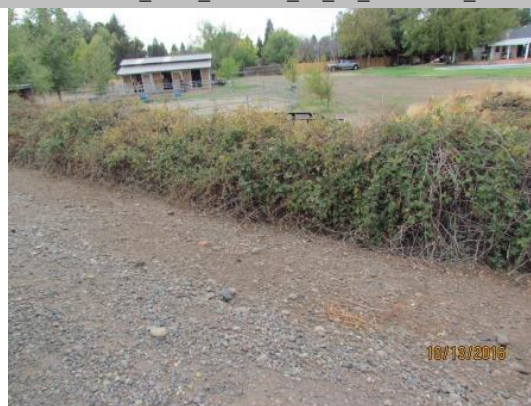
Photo 1 of 1 : SP_2018_NA0003_64_22_20180305_00005.jpg

LM Start	5.96	Rating **	M	Issue No.	22
LM End	5.96	Issue Type +	Ma	Location *	LS
Category	Earthen Levee			GPS Latitude/Longitude	
				Start	End
Item	Vegetation			39.793116 °	39.793116 °
				-121.887296 °	-121.887296 °
DWR ID	DWR_NA0003_01_f_2016_22				
Comment Code					
V4 : Elderberries are blocking visibility and flood fight capability.					
Inspector Comment					
Blackberry bramble

View of the blackberries blocking visibility and access.

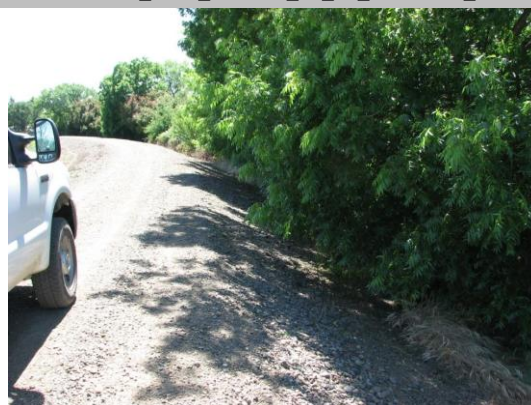
Photo 1 of 1 : SP_2018_NA0003_64_37_20180305_00018.jpg

LM Start	5.98	Rating **	U	Issue No.	37
LM End	6.07	Issue Type +	Ma	Location *	LS
Category	Earthen Levee			GPS Latitude/Longitude	
				Start	End
Item	Vegetation			39.793411 °	39.794580 °
				-121.887310 °	-121.886759 °
DWR ID	DWR_NA0003_01_s_2016_37				
Comment Code					
V7 : Trees / Woody Vegetation					
Inspector Comment					
Various overgrown vegetation completely obscuring landside toe visibility.

04/25/2016: Trim trees on L/S slope.

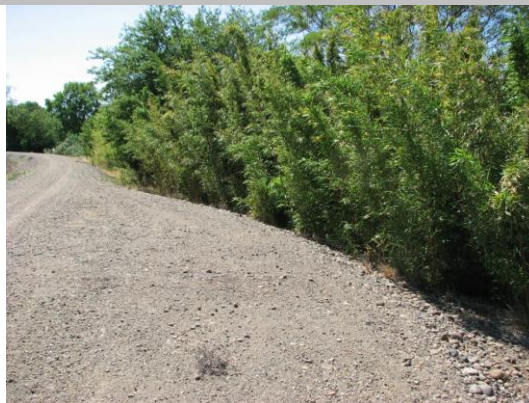
Photo 1 of 1 : SP_2018_NA0003_64_35_20180305_00017.jpg

LM Start	6.09	Rating **	U	Issue No.	35
LM End	6.13	Issue Type +	En	Location *	LS
Category	Earthen Levee			GPS Latitude/Longitude	
				Start	End
Item	Vegetation			39.794875 °	39.795179 °
				-121.886394 °	-121.885835 °
DWR ID	DWR_NA0003_01_s _ 2016_35				
Comment Code					
V6 : Landscaping					
Inspector Comment					
Bamboo vegetation along landside toe blocking visibility.

View of bamboo blocking visibility and access.

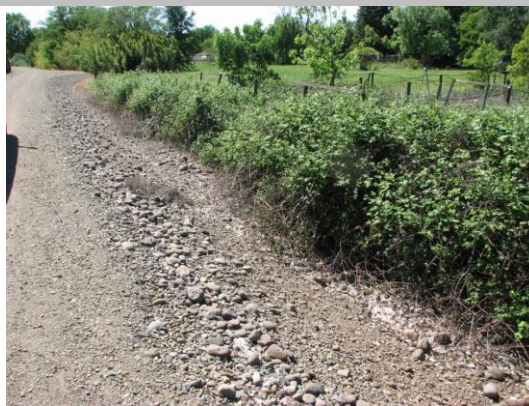
Photo 1 of 1 : SP_2018_NA0003_64_34_20180305_00016.jpg

LM Start	6.16	Rating **	M	Issue No.	34
LM End	6.16	Issue Type +	Ma	Location *	LS
Category	Earthen Levee			GPS Latitude/Longitude	
				Start	End
Item	Vegetation			39.795428 °	39.795428 °
				-121.885306 °	-121.885306 °
DWR ID	DWR_NA0003_01_s _ 2016_34				
Comment Code					
V2 : Remove the wild growth other than native grasses from the levee slopes.					
Inspector Comment					
Blackberry bramble on landside toe blocking visibility.

Trim vegetation at L/S toe.

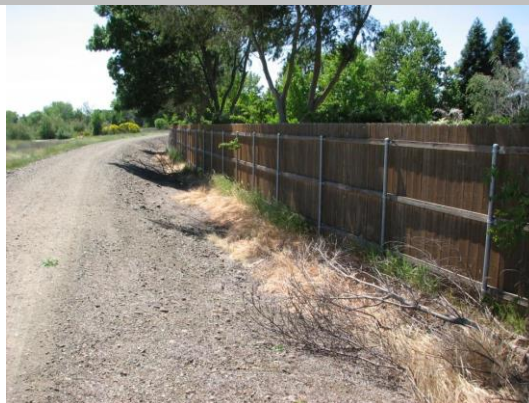
Photo 1 of 1 : SP_2018_NA0003_64_28_20180305_00010.jpg

LM Start	6.43	Rating **	U	Issue No.	28
LM End	6.47	Issue Type +	En	Location *	LS
Category	Earthen Levee			GPS Latitude/Longitude	
				Start	End
Item	Encroachments			39.798166 °	39.798492 °
				-121.882236 °	-121.881722 °
DWR ID	DWR_NA0003_01_s_2016_28				
Comment Code					
FE : Fence					
Inspector Comment					
6' high wooden fencing at landside toe.

View of the fence blocking visibility and access along the landside toe.

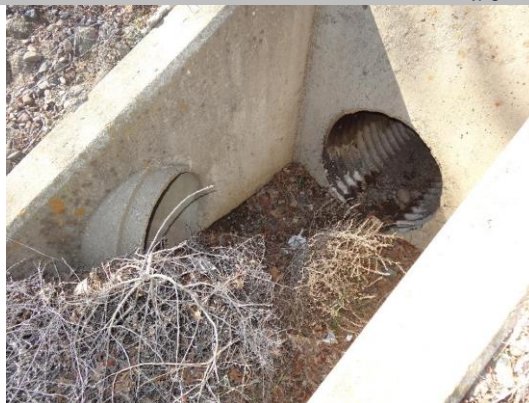
Photo 2 of 2 : UCIP_SP_2018_30743_56640.jpg

Comment Code						
Inspector Comment						
FS_ID:30743						
DS_ID:19237						
EP_NO: N/A						
Repair Type: Non-Urgent						
Crossing Status: Found						
UCIP Comments: Needs cleaning and clearing of debris.						
FIELD_STRUCT_DESC: 24-inch corrugated metal gravity drainage pipe						
through the levee, 11 feet below the crown. Flap gate on the waterside						
(WS) end. Concrete U-shaped headwall on each end. Grouted riprap						
apron on the landside (LS) end. Grouted riprap spillway on the WS end.						
[Additional Reference(s): DWR Levee Log, 1992. USACE Sacramento						
O&M Manual 504, May 1965, (HLM 1.55)].						
FS Date: 2/24/2014

LS view: U type concrete headwall and CMP on levee slope. Vegetation debris and soil in inlet area.

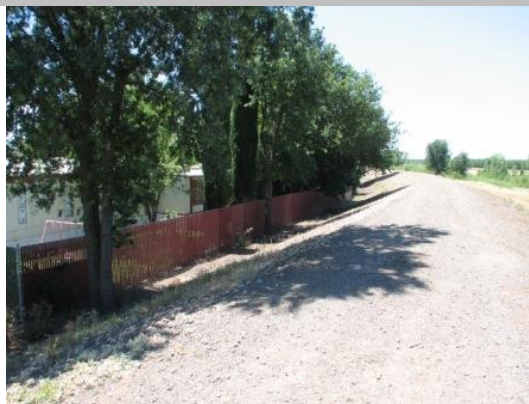
Photo 1 of 1 : SP_2018_NA0003_65_3_20180305_00002.jpg

LM Start	1.49	Rating **	U	Issue No.	3
LM End	1.81	Issue Type +	En	Location *	LS
Category	Earthen Levee			GPS Latitude/Longitude	
				Start	End
Item	Encroachments			39.782773 °	39.778972 °
				-121.888178 °	-121.891563 °
DWR ID	DWR_NA0003_02_s_2012_3				
Comment Code					
FE : Fence					
Inspector Comment					
The fence is within the easement.

View of the fence along the landside toe of the levee.

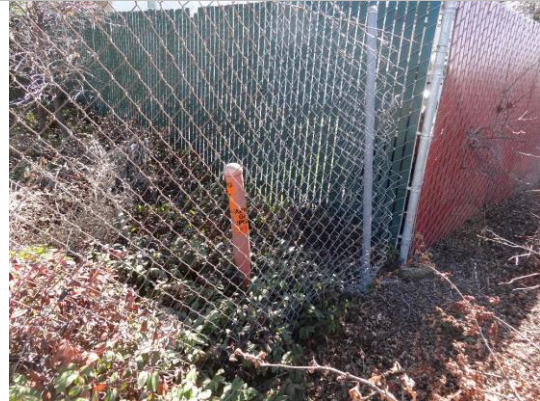
Photo 1 of 1 : UCIP_SP_2018_41873_56643.jpg

LM Start	1.49	Rating **	M	Issue No.	44
LM End	1.49	Issue Type +	En	Location *	
Category	Supplemental			GPS Latitude/Longitude	
				Start	End
Item	DWR UCIP Field Study			39.782766 °	39.782766 °
				-121.888187 °	-121.888187 °
DWR ID					
Comment Code					
Inspector Comment					
FS_ID:41873 DS_ID:24803 EP_NO: 9874 Repair Type: Non-Urgent Crossing Status: Indicator Found UCIP Comments: May need to contact owner to determine status of crossing and install markers as appropriate. FIELD_STRUCT_DESC: 6-inch natural gas main of an unknown material through both levees and under Mud Creek, downstream from the Esplanade, at an unknown depth. Indicator on the landside (LS) toe. (Plans to install a 6-inch natural gas pipeline across Mud Creek and through adjacent levee authorized under Permit No. 9874, 1974 - Pacific Gas and Electric Company [PG&E]). FS Date: 2/24/2014

LS view: gasline marker on levee toe.

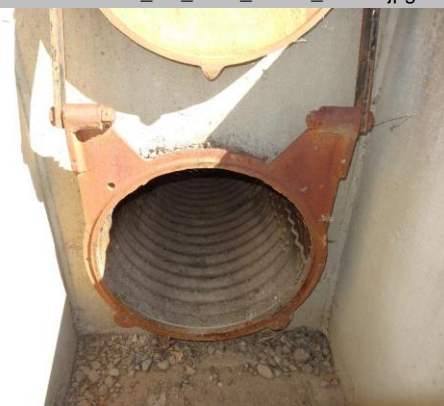
Photo 2 of 3 : UCIP_SP_2018_41375_56645.jpg

Comment Code						
Inspector Comment						
FS_ID:41375 DS_ID:19238 EP_NO: 12619A Repair Type: Non-Urgent Crossing Status: Found UCIP Comments: - 24-inch CM pipe.- inlet and spillway may need cleaning and clearing. FIELD_STRUCT_DESC: 24-inch corrugated metal gravity storm drainage pipe through the levee, 11 feet below the crown. Flap gate on the waterside (WS) end. Concrete U-shaped headwall on each end. Grouted riprap apron on the landside (LS) end. Grouted riprap spillway on the WS end. (Plans to replace an existing 24-inch storm drain inlet to the Mud Creek Diversion Channel with a 36-inch storm drain located approximately 500 feet upstream from Nord Highway authorized under Permit No. 12619, 1979 - Richard E. Vermillion. Plans for extension of time to replace an existing 24-inch storm drain inlet to the Mud Creek Diversion Channel with a 36-inch storm drain located upstream from Nord Highway authorized under Permit No. 12619-A, 1980 - Richard E. Vermillion). The storm drain never got replaced. [Additional Reference(s): DWR Levee Log, 1992, 36-inch pipe referenced. USACE Sacramento O&M Manual 504, May 1965, (HLM 2.13)]. FS Date: 2/24/2014

WS view: U type concrete headwall, pipe, and flapgate on levee slope.

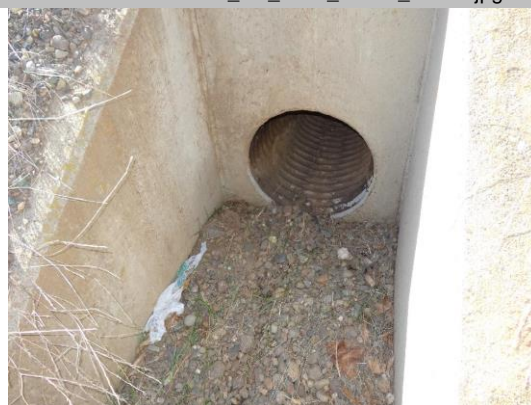
Photo 3 of 3 : UCIP_SP_2018_41375_56644.jpg

LS view: U type concrete headwall and CMP on levee slope.

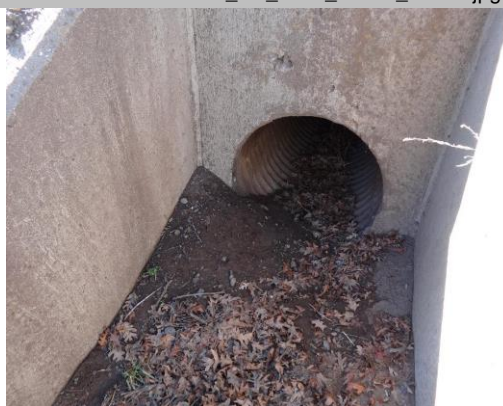
Photo 2 of 3 : UCIP_SP_2018_30783_56681.jpg

LM Start	2.74	Rating **	M	Issue No.	47 (cont)	
LM End	2.74	Issue Type +	Ma	Location *		
Category	Supplemental			GPS Latitude/Longitude		
				Start		End
Item	DWR UCIP LMA Responsibility			39.768741 °	39.768741 °	
				-121.901176 °	-121.901176 °	
DWR ID						
Comment Code						
Inspector Comment						
FS_ID:30783						
DS_ID:19240						
EP_NO: N/A						
Repair Type: Non-Urgent						
Crossing Status: Found						
UCIP Comments: Needs cleaning and clearing of debris.						
FIELD_STRUCT_DESC: 24-inch corrugated metal gravity drainage pipe through the levee, 10 feet below the crown. Flap gate on the waterside (WS) end. Concrete U-shaped headwall on each end. Grouted riprap apron on the landside (LS) end. Grouted riprap spillway on the WS end. [Additional Reference(s): DWR Levee Log, 1992. USACE Sacramento O&M Manual 504, May 1965, (HLM 2.86)].						
FS Date: 2/24/2014

LS view: U type concrete headwall and CMP on levee slope. Debris and soil in inlet box.

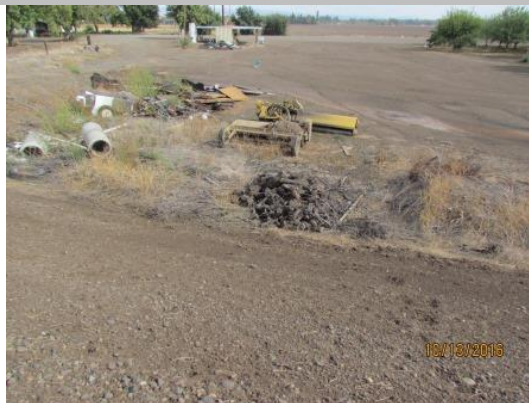
Photo 1 of 1 : SP_2018_NA0003_65_1_20180305_00001.jpg

LM Start	2.80	Rating **	M	Issue No.	1
LM End	2.80	Issue Type +	En	Location *	LS
Category	Earthen Levee			GPS Latitude/Longitude	
				Start	End
Item	Encroachments			39.767841 °	39.767841 °
				-121.901534 °	-121.901534 °
DWR ID	DWR_NA0003_02_f_2013_1				
Comment Code					
FW : Firewood					
Inspector Comment					
Remove firewood and broken concrete pipes from the landside toe.

View of the firewood and broken concrete pipes along the landside toe.

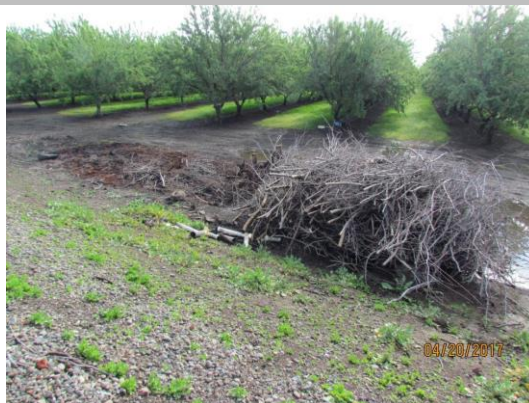
Photo 1 of 2 : SP_2018_NA0003_65_5_20180305_00003.jpg

LM Start	3.31	Rating **	M	Issue No.	5
LM End	3.31	Issue Type +	En	Location *	LS
Category	Earthen Levee			GPS Latitude/Longitude	
				Start	End
Item	Encroachments			39.763208 °	39.763208 °
				-121.908517 °	-121.908517 °
DWR ID	DWR_NA0003_02_f_2012_5				
Comment Code					
PR : Prunings					
Inspector Comment

View of the prunings along the landside toe.

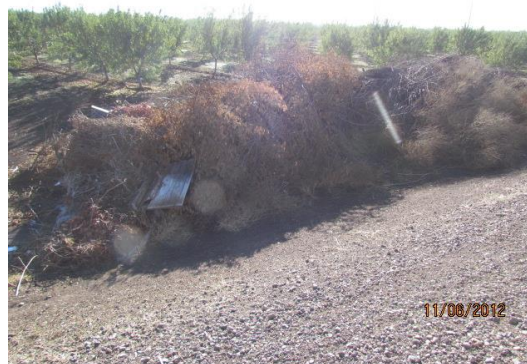
Photo 2 of 2 : SP_2018_NA0003_65_5_20180305_00004.jpg

LM Start	3.31	Rating **	M	Issue No.	5 (cont)	
LM End	3.31	Issue Type +	En	Location *	LS	
Category	Earthen Levee			GPS Latitude/Longitude		
				Start		End
Item	Encroachments			39.763208 °		39.763208 °
				-121.908517 °		-121.908517 °
DWR ID	DWR_NA0003_02_f_2012_5					
Comment Code						
PR : Prunings						
Inspector Comment

View of the brush pile along landside toe.

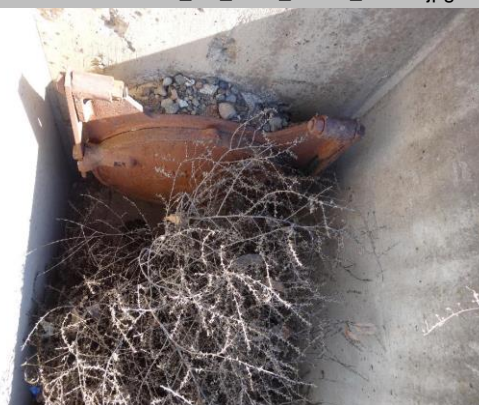
Photo 1 of 3 : UCIP_SP_2018_30803_56685.jpg

LM Start	3.50	Rating **	M	Issue No.	48
LM End	3.50	Issue Type +	Ma	Location *	
Category	Supplemental			GPS Latitude/Longitude	
				Start	End
Item	DWR UCIP LMA Responsibility			39.760847 °	39.760847 °
				-121.910265 °	-121.910265 °
DWR ID					
Comment Code					
Inspector Comment					
FS_ID:30803 DS_ID:19241 EP_NO: N/A Repair Type: Non-Urgent Crossing Status: Found UCIP Comments: Needs cleaning and clearing of debris. FIELD_STRUCT_DESC: 24-inch corrugated metal gravity drainage pipe through the levee, 6.5 feet below the crown. Flap gate on the waterside (WS) end. Concrete U-shaped headwall on each end. Grouted riprap apron on the landside (LS) end. Grouted riprap spillway on the WS end. [Additional Reference(s): DWR Levee Log, 1992. USACE Sacramento O&M Manual 504, May 1965, (HLM 3.64)]. FS Date: 2/24/2014

WS view: U type concrete headwall, pipe, and flapgate on levee slope.
Vegetation debris and soil blocking outlet.

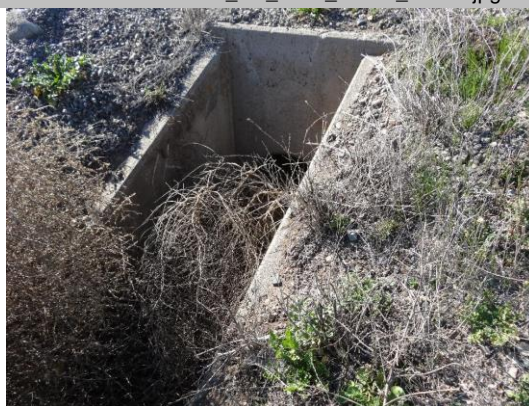
Photo 2 of 3 : UCIP_SP_2018_30803_56684.jpg

LM Start	3.50	Rating **	M	Issue No.	48 (cont)	
LM End	3.50	Issue Type +	Ma	Location *		
Category	Supplemental			GPS Latitude/Longitude		
				Start		End
Item	DWR UCIP LMA Responsibility			39.760847 °		39.760847 °
				-121.910265 °		-121.910265 °
DWR ID						
Comment Code						
Inspector Comment						
FS_ID:30803						
DS_ID:19241						
EP_NO: N/A						
Repair Type: Non-Urgent						
Crossing Status: Found						
UCIP Comments: Needs cleaning and clearing of debris.						
FIELD_STRUCT_DESC: 24-inch corrugated metal gravity drainage pipe through the levee, 6.5 feet below the crown. Flap gate on the waterside (WS) end. Concrete U-shaped headwall on each end. Grouted riprap apron on the landside (LS) end. Grouted riprap spillway on the WS end. [Additional Reference(s): DWR Levee Log, 1992. USACE Sacramento O&M Manual 504, May 1965, (HLM 3.64)].						
FS Date: 2/24/2014

LS view: U type concrete headwall and CMP on levee slope. Vegetation debris and soil blocking inlet.

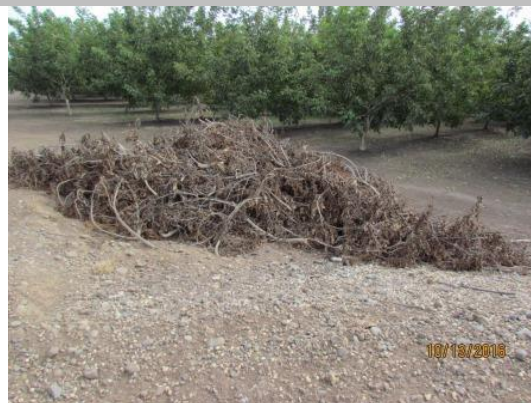
Photo 1 of 1 : SP_2018_NA0003_65_33_20180305_00011.jpg

LM Start	3.95	Rating **	M	Issue No.	33
LM End	3.95	Issue Type +	En	Location *	LS
Category	Earthen Levee			GPS Latitude/Longitude	
				Start	End
Item	Encroachments			39.755681 °	39.755681 °
				-121.910628 °	-121.910628 °
DWR ID	DWR_NA0003_02_f_2016_33				
Comment Code					
PR : Prunings					
Inspector Comment					
Remove prunings from the landside toe.

View of the prunings along the landside toe.

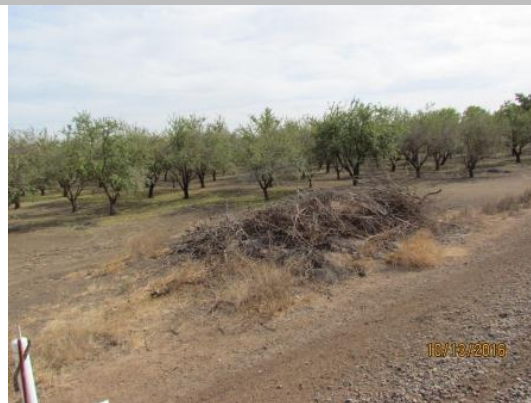
Photo 1 of 1 : SP_2018_NA0003_65_34_20180305_00012.jpg

LM Start	4.54	Rating **	M	Issue No.	34
LM End	4.54	Issue Type +	En	Location *	LS
Category	Earthen Levee			GPS Latitude/Longitude	
				Start	End
Item	Encroachments			39.749708 °	39.749708 °
				-121.917162 °	-121.917162 °
DWR ID	DWR_NA0003_02_f_2016_34				
Comment Code					
PR : Prunings					
Inspector Comment					
Remove prunings from the landside toe.

View of the prunings along the landside toe.

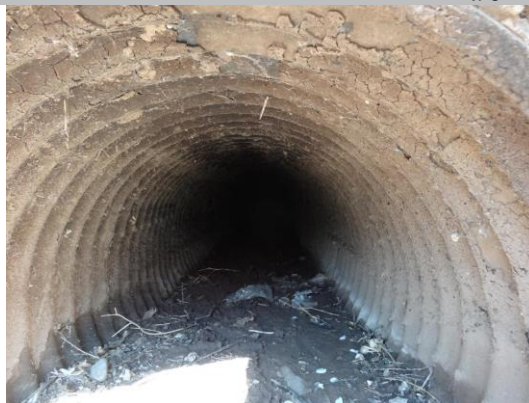
Photo 3 of 3 : UCIP_SP_2018_31031_56915.jpg

LM Start	5.64	Rating **	M	Issue No.	50 (cont)	
LM End	5.64	Issue Type +	Ma	Location *		
Category	Supplemental			GPS Latitude/Longitude		
				Start	End	
Item	DWR UCIP LMA Responsibility			39.738898 °	39.738898 °	
				-121.930242 °	-121.930242 °	
DWR ID						
Comment Code						
Inspector Comment						
FS_ID:31031 DS_ID:19247 EP_NO: N/A Repair Type: Non-Urgent Crossing Status: Found UCIP Comments: Needs cleaning and clearing of debris. FIELD_STRUCT_DESC: 24-inch corrugated metal gravity drainage pipe through the levee, 11.5 feet below the crown. Flap gate on the waterside (WS) end. Concrete U-shaped headwall on each end. Grouted riprap apron on the landside (LS) end. Grouted riprap spillway on the WS end. [Additional Reference(s): DWR Levee Log, 1992. USACE Sacramento O&M Manual 504, May 1965, (HLM 5.83)]. FS Date: 2/25/2014

LS view: inside view of CMP on levee slope. Needs cleaning and clearing.

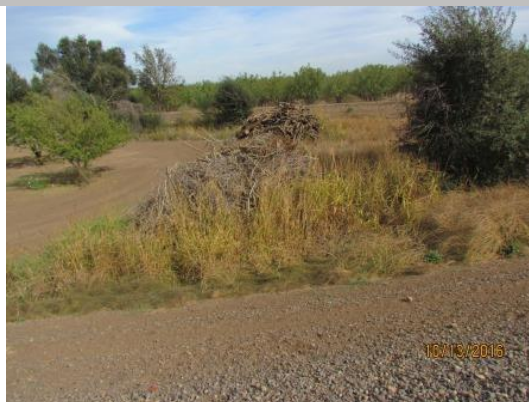
Photo 1 of 1 : SP_2018_NA0003_65_35_20180305_00013.jpg

LM Start	6.07	Rating **	M	Issue No.	35
LM End	6.07	Issue Type +	En	Location *	LS
Category	Earthen Levee			GPS Latitude/Longitude	
				Start	End
Item	Encroachments			39.733583 °	39.733583 °
				-121.930511 °	-121.930511 °
DWR ID	DWR_NA0003_02_f_2016_35				
Comment Code					
PR : Prunings					
Inspector Comment					
Remove prunings from the landside toe.

View of the prunings along the landside toe.

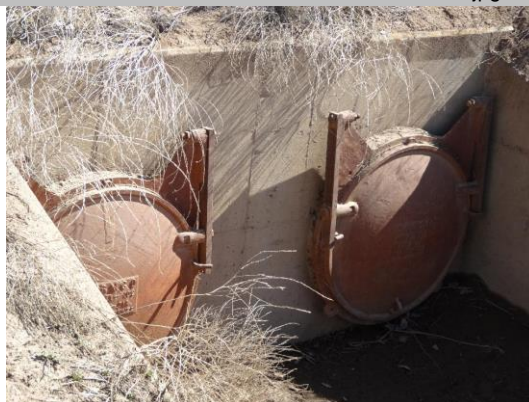
Photo 2 of 3 : UCIP_SP_2018_41376_56919.jpg

WS view: U type concrete headwall, pipes, and flapgates on levee slope. Vegetation debris on outlet box.

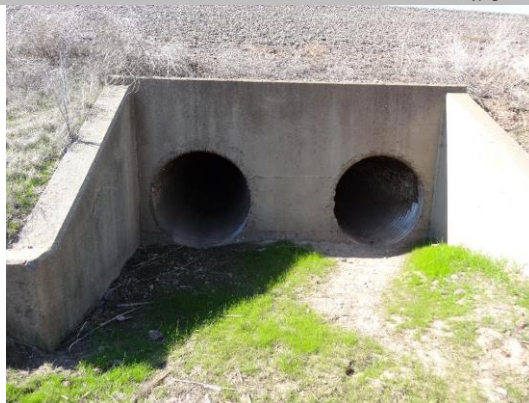
Photo 3 of 3 : UCIP_SP_2018_41376_56918.jpg

Comment Code						
Inspector Comment						
FS_ID:41376 DS_ID:19248 EP_NO: N/A Repair Type: Non-Urgent Crossing Status: Found UCIP Comments: Needs cleaning and clearing of debris. FIELD_STRUCT_DESC: [Channel Slough Drainage Structure] 1 of 2: 42-inch corrugated metal gravity drainage pipe through the levee, 16 feet below the crown. Flap gate on the waterside (WS) end. Slide gate in a corrugated metal pipe (CMP) riser on the WS slope. Concrete U-shaped headwall on each end. Grouted riprap apron and rock revetment on the landside (LS) end. [Additional Reference(s): DWR Levee Log, 1992. USACE Sacramento O&M Manual 504, May 1965, (HLM 6.30)]. FS Date: 2/25/2014

LS view: U type concrete headwall and CMPs on levee slope. Soil/mud on inlet box.

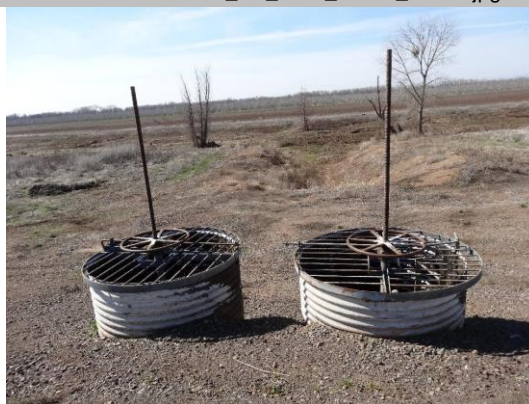
Photo 1 of 3 : UCIP_SP_2018_41377_56923.jpg

Comment Code					
Inspector Comment					
FS_ID:41377 DS_ID:19259 EP_NO: N/A Repair Type: Non-Urgent Crossing Status: Found UCIP Comments: Needs cleaning and clearing of debris. FIELD_STRUCT_DESC: [Channel Slough Drainage Structure] 2 of 2: 42-inch corrugated metal gravity drainage pipe through the levee, 16 feet below the crown. Flap gate on the waterside (WS) end. Slide gate in a corrugated metal pipe (CMP) riser on the WS slope. Concrete U-shaped headwall on each end. Grouted riprap apron and rock revetment on the landside (LS) end. [Additional Reference(s): DWR Levee Log, 1992. USACE Sacramento O&M Manual 504, May 1965, (HLM 6.30)]. FS Date: 2/25/2014

WS view: slide gates in CMP risers on levee slope.

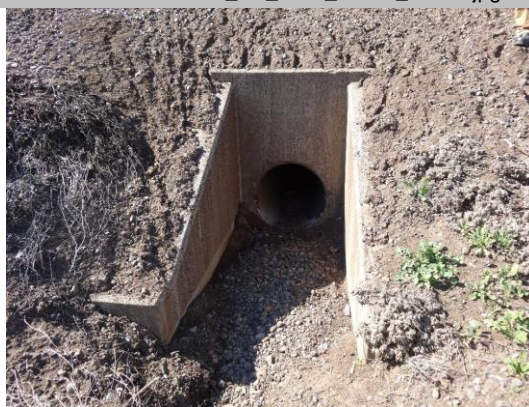
Photo 2 of 3 : UCIP_SP_2018_31034_56925.jpg

LS view: U type concrete headwall and CMP on levee slope.

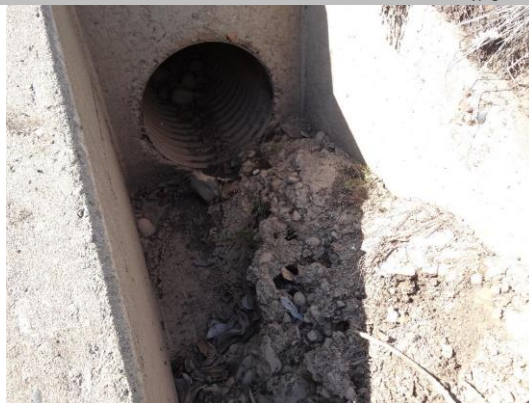
Photo 2 of 3 : UCIP_SP_2018_31085_56987.jpg

LM Start	6.43	Rating **	M	Issue No.	54 (cont)	
LM End	6.43	Issue Type +	Ma	Location *		
Category	Supplemental			GPS Latitude/Longitude		
				Start		End
Item	DWR UCIP LMA Responsibility			39.728812 °		39.728812 °
				-121.932623 °		-121.932623 °
DWR ID						
Comment Code						
Inspector Comment						
FS_ID:31085 DS_ID:19251 EP_NO: N/A Repair Type: Non-Urgent Crossing Status: Found UCIP Comments: Needs cleaning and clearing of debris. FIELD_STRUCT_DESC: 24-inch corrugated metal gravity drainage pipe through the levee, 15.5 feet below the crown. Flap gate on the waterside (WS) end. Concrete U-shaped headwall on each end. Grouted riprap apron on the landside (LS) end. Grouted riprap spillway on the WS end. [Additional Reference(s): DWR Levee Log, 1992. USACE Sacramento O&M Manual 504, May 1965, (HLM 6.65)]. FS Date: 2/25/2014

LS view: U type concrete headwall and CMP on levee slope. Soil/mud on inlet box.

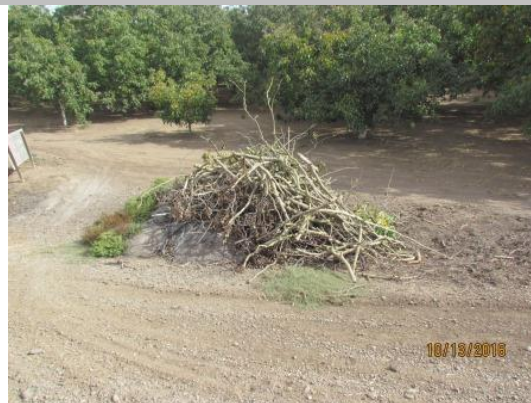
Photo 1 of 1 : SP_2018_NA0003_65_37_20180305_00014.jpg

LM Start	6.44	Rating **	M	Issue No.	37
LM End	6.44	Issue Type +	En	Location *	LS
Category	Earthen Levee			GPS Latitude/Longitude	
				Start	End
Item	Encroachments			39.728779 °	39.728779 °
				-121.932679 °	-121.932679 °
DWR ID	DWR_NA0003_02_f_2016_37				
Comment Code					
PR : Prunings					
Inspector Comment					
Remove prunings from the landside toe.

View of the prunings along the landside toe.

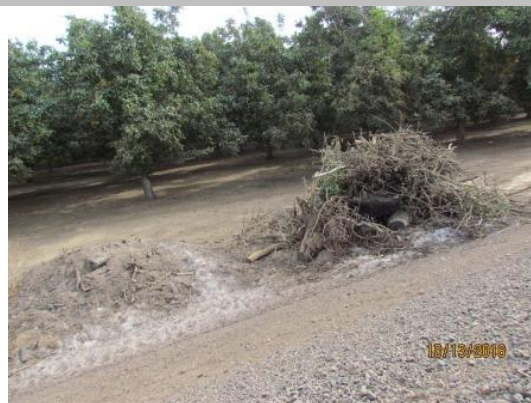
Photo 1 of 1 : SP_2018_NA0003_65_38_20180305_00015.jpg

LM Start	6.71	Rating **	M	Issue No.	38
LM End	6.71	Issue Type +	En	Location *	LS
Category	Earthen Levee			GPS Latitude/Longitude	
				Start	End
Item	Encroachments			39.725695 °	39.725695 °
				-121.935791 °	-121.935791 °
DWR ID	DWR_NA0003_02_f_2016_38				
Comment Code					
PR : Prunings					
Inspector Comment					
Remove prunings from the landside toe.

View of the prunings along the landside toe.

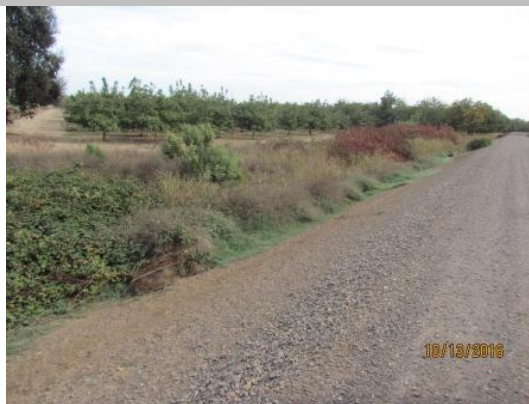
Photo 1 of 1 : SP_2018_NA0003_65_40_20180305_00017.jpg

LM Start	7.17	Rating **	M	Issue No.	40
LM End	7.22	Issue Type +	Ma	Location *	LS
Category	Earthen Levee			GPS Latitude/Longitude	
				Start	End
Item	Vegetation			39.719593 °	39.718933 °
				-121.938137 °	-121.937635 °
DWR ID	DWR_NA0003_02_f_2016_40				
Comment Code					
V2 : Remove the wild growth other than native grasses from the levee slopes.					
Inspector Comment

View of the dense vegetation along the landside toe blocking visibility and access.

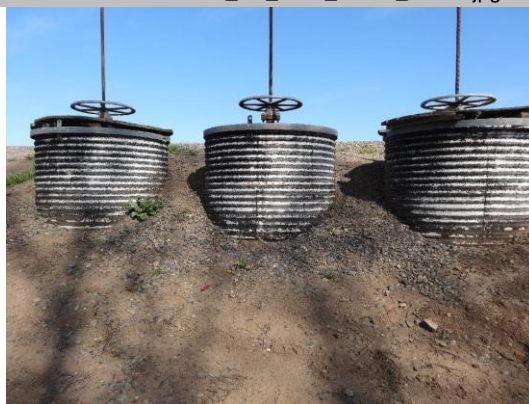
Photo 1 of 3 : UCIP_SP_2018_32087_58592.jpg

Comment Code					
Inspector Comment					
FS_ID:32087 DS_ID:19261 EP_NO: N/A Repair Type: Non-Urgent Crossing Status: Found UCIP Comments: Slide gates in CMP risers on waterside shoulder.Needs cleaning and clearing on both pipe ends. FIELD_STRUCT_DESC: 3 of 3: 48-inch corrugated metal gravity drainage pipe through the levee, 18 feet below the crown. Flap gate on the waterside (WS) end. Slide gate in a corrugated metal pipe (CMP) riser on the WS shoulder. Concrete U-shaped headwall on each end. Grouted riprap apron on the landside (LS) end. Grouted riprap spillway on the WS end. [Additional Reference(s): DWR Levee Log, 1992. USACE Sacramento O&M Manual 504, May 1965, (HLM 7.46)]. FS Date: 2/25/2014

WS view: slide gates in CMP risers on waterside shoulder.

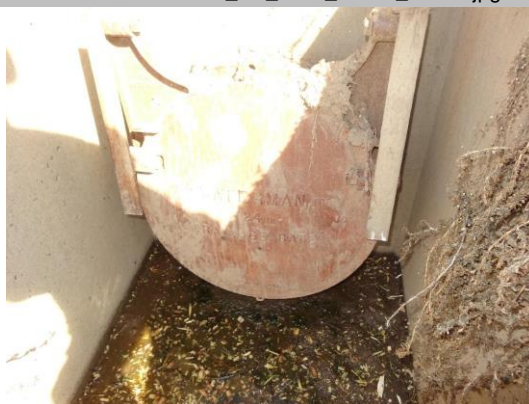
Photo 1 of 2 : UCIP_SP_2018_31129_57036.jpg

LM Start	7.77	Rating **	M	Issue No.	59
LM End	7.77	Issue Type +	Ma	Location *	
Category	Supplemental			GPS Latitude/Longitude	
				Start	End
Item	DWR UCIP LMA Responsibility			39.711436 °	39.711436 °
				-121.937135 °	-121.937135 °
DWR ID					
Comment Code					
Inspector Comment					
FS_ID:31129 DS_ID:19254 EP_NO: N/A Repair Type: Non-Urgent Crossing Status: Found UCIP Comments: Debris in inlet pipe, needs cleaning and clearing. FIELD_STRUCT_DESC: 24-inch corrugated metal gravity drainage pipe through the levee, 18 feet below the crown. Flap gate on the waterside (WS) end. Concrete U-shaped headwall on each end. Grouted riprap apron on the landside (LS) end. Grouted riprap spillway on the WS end. [Additional Reference(s): DWR Levee Log, 1992. USACE Sacramento O&M Manual 504, May 1965, (HLM 8.09)]. FS Date: 2/25/2014

WS view: U type concrete headwall, pipe, and flapgate on levee slope. Soil/mud on outlet box.

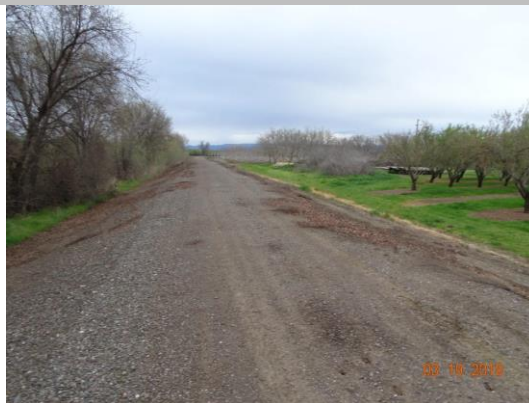
Photo 1 of 1 : SP_2018_NA0003_66_3_20180402_00001.jpg

LM Start	0.10	Rating **	A	Issue No.	3
LM End	0.10	Issue Type +	Ma	Location *	LS
Category	Earthen Levee			GPS Latitude/Longitude	
				Start	End
Item	Vegetation			39.734240 °	39.734240 °
				-121.929565 °	-121.929565 °
DWR ID	DWR_NA0003_02A_s _ 2018_3				
Comment Code					
V1 : Control annual grass and weeds on the levee slopes and easements.					
Inspector Comment					
There is no vegetation on both slopes.

View of no vegetation on both slopes.

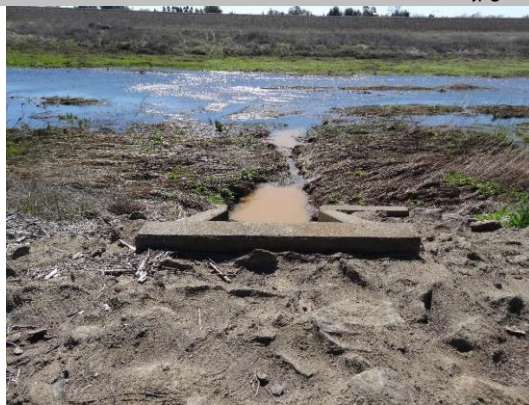
Photo 2 of 3 : UCIP_SP_2018_51844_58601.jpg

WS view: U type concrete headwall of CMP culvert on levee slope. Grouted riprap levee slope and spillway.

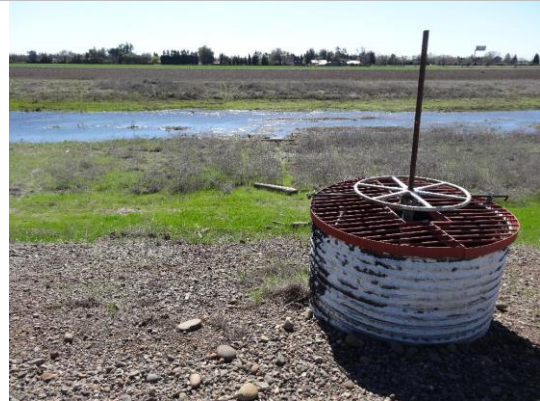
Photo 3 of 3 : UCIP_SP_2018_51844_58600.jpg

WS view: slide gate in CMP riser on waterside shoulder.

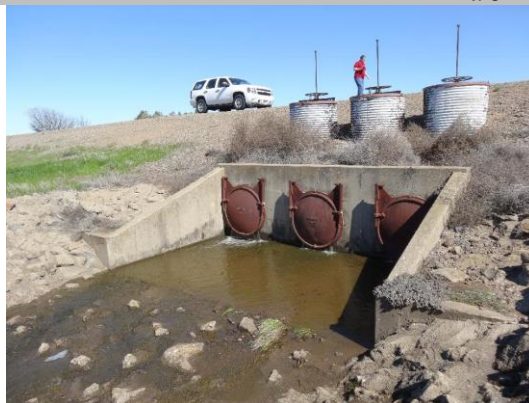
Photo 1 of 2 : UCIP_SP_2018_32104_58606.jpg

LM Start	0.39	Rating **	A/W	Issue No.	24
LM End	0.39	Issue Type +	Ma	Location *	
Category	Supplemental			GPS Latitude/Longitude	
				Start	End
Item	DWR UCIP LMA Responsibility			39.785262 °	39.785262 °
				-121.876622 °	-121.876622 °
DWR ID					
Comment Code					
Inspector Comment					
FS_ID:32104 DS_ID:19278 EP_NO: N/A Repair Type: No Action Needed Crossing Status: Found UCIP Comments: Slide gate in CMP riser on waterside.The culvert was working during the field visit. FIELD_STRUCT_DESC: 1 of 3: 48-inch corrugated metal gravity drainage pipe through the levee, 11.7 feet below the crown. Slide gate in a riser well on the waterside (WS) slope. Concrete U-shaped headwall on each end. Flap gate on the WS end. Grouted riprap outlet channel on the WS. [Additional Reference(s): DWR Levee Log, 1992. USACE Sacramento O&M Manual 504, May 1965, (HLM 0.39)]. FS Date: 3/11/2014

WS view: U type concrete headwall and three CMPs with slide gates on levee slope. Grouted riprap spillway.

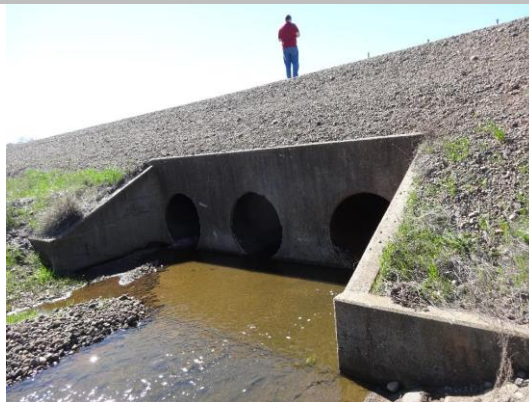
Photo 2 of 2 : UCIP_SP_2018_32104_58605.jpg

LS view: U type concrete headwall and three CMPs on levee slope. Soil/mud on inlet box.

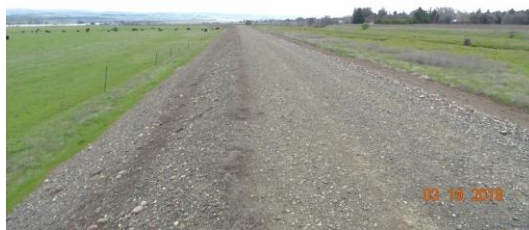
Photo 1 of 1 : SP_2018_NA0003_67_22_20180402_00038.jpg

LM Start	1.34	Rating **	A	Issue No.	22
LM End	1.34	Issue Type +	Ma	Location *	LS
Category	Earthen Levee			GPS Latitude/Longitude	
				Start	End
Item	Vegetation			39.779405 °	39.779405 °
				-121.860965 °	-121.860965 °
DWR ID	DWR_NA0003_03_s_2018_22				
Comment Code					
V1 : Control annual grass and weeds on the levee slopes and easements.					
Inspector Comment					
There is no vegetation on both slopes.

View of the levee with no vegetation on both slopes.

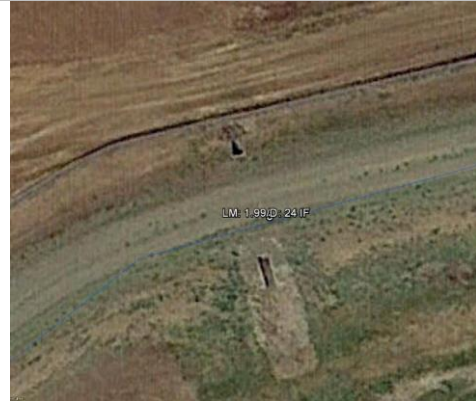
Photo 1 of 1 : UCIP_SP_2018_31900_58189.jpg

LM Start	1.96	Rating **	M	Issue No.	29
LM End	1.96	Issue Type +	En	Location *	
Category	Supplemental			GPS Latitude/Longitude	
				Start	End
Item	DWR UCIP Field Study			39.781714 °	39.781714 °
				-121.850868 °	-121.850868 °
DWR ID					
Comment Code					
Inspector Comment					
FS_ID:31900					
DS_ID:19266					
EP_NO: N/A					
Repair Type: Non-Urgent					
Crossing Status: Indicator Found					
UCIP Comments: Needs location confirmation, GPS reading has not taken due to access problem.					
FIELD_STRUCT_DESC: 24-inch corrugated metal gravity drainage pipe through the levee, 8 feet below the crown. Flap gate on the waterside (WS) end. Concrete U-shaped headwall on each end. Grouted riprap apron on the landside (LS) end. Grouted riprap spillway on the WS end. [Additional Reference(s): DWR Levee Log, 1992. USACE Sacramento O&M Manual 504, May 1965, (HLM 2.00)].					
FS Date: 3/11/2014

Bird's eye view: concrete headwall visible on both sides of the levee.
Grouted riprap spillway on waterside.
